DEFENDANT'S EXPERT REPORT

**Re: George Collins and
Alrika Collins,
Plaintiffs,**

**State Farm Fire and
Casualty Company,
Defendant.**

**United States District Court for
the Eastern District of Oklahoma
Case #: 22-CV-00318-RAW-JAR**

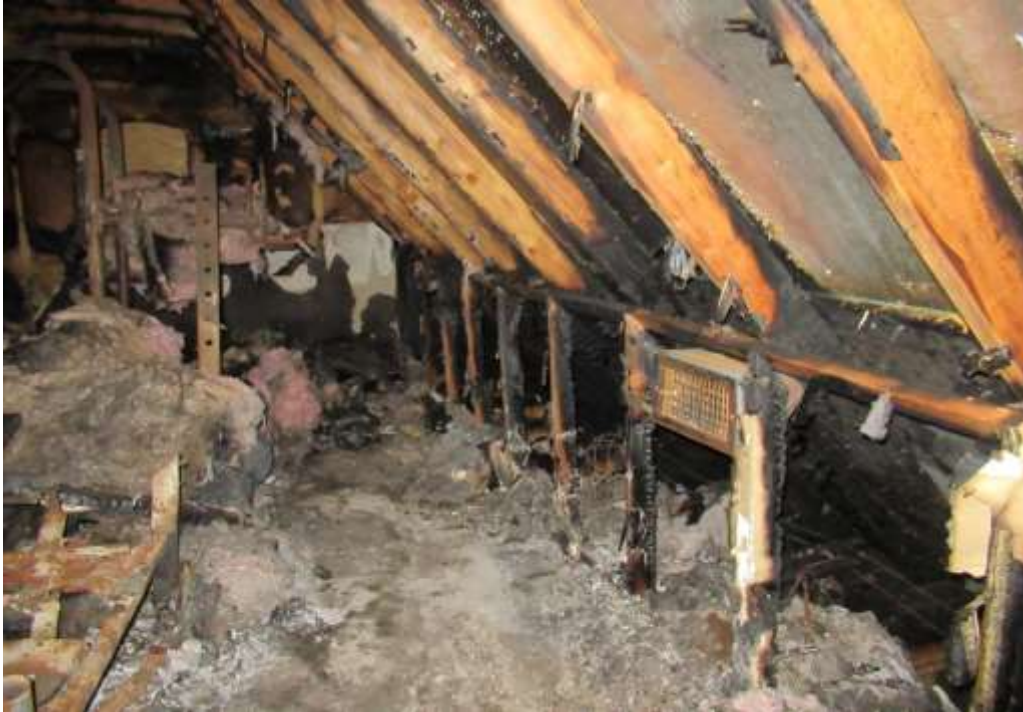
The west wall and sloped ceiling of the exercise room with the attic space just beyond the vertical stud wall framing members. This is near the reported fire origin.

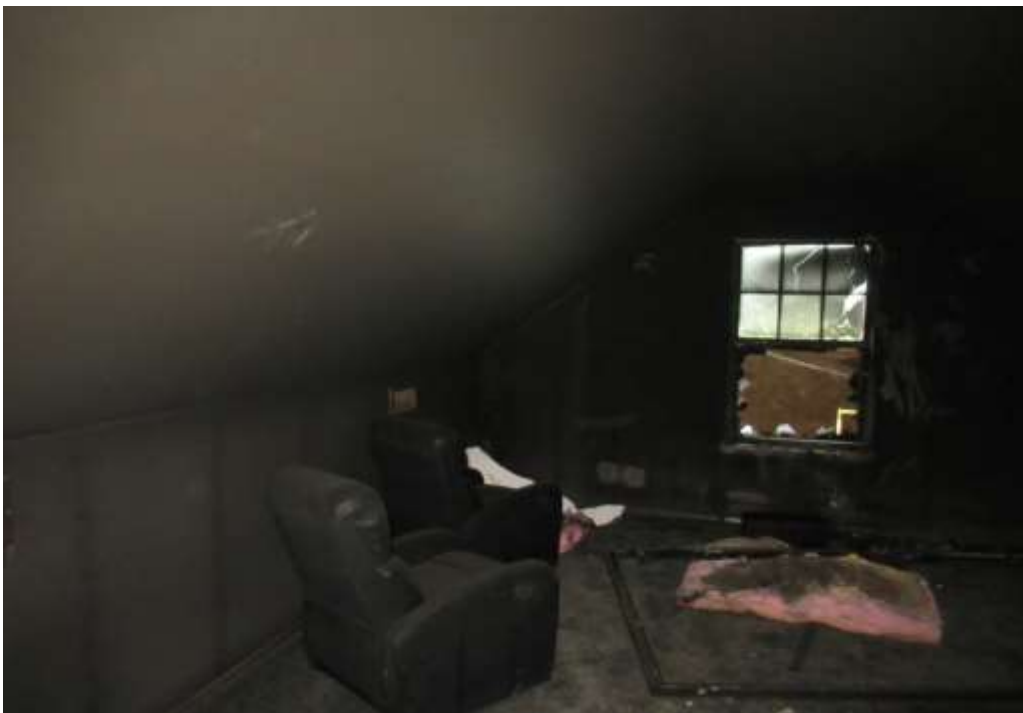
The south wall of the movie room with the fire being contained behind the sheetrock and within the attic cavity.

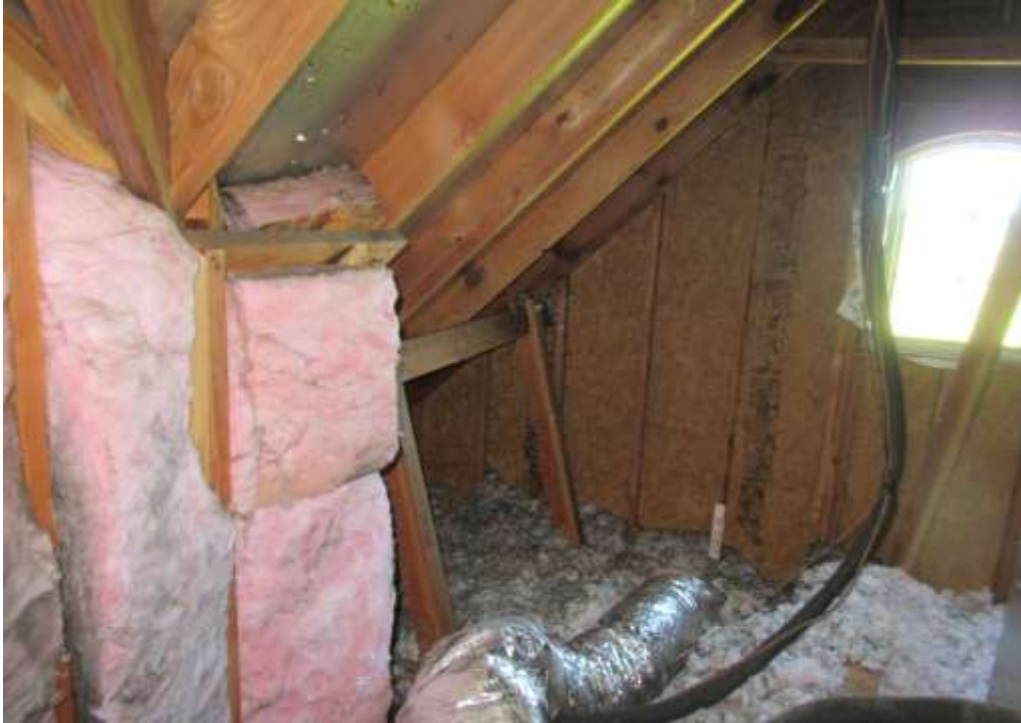
The walk-in attic to the east of the theater room. This area suffered no fire damage.
Minimal smoke residue was evident.

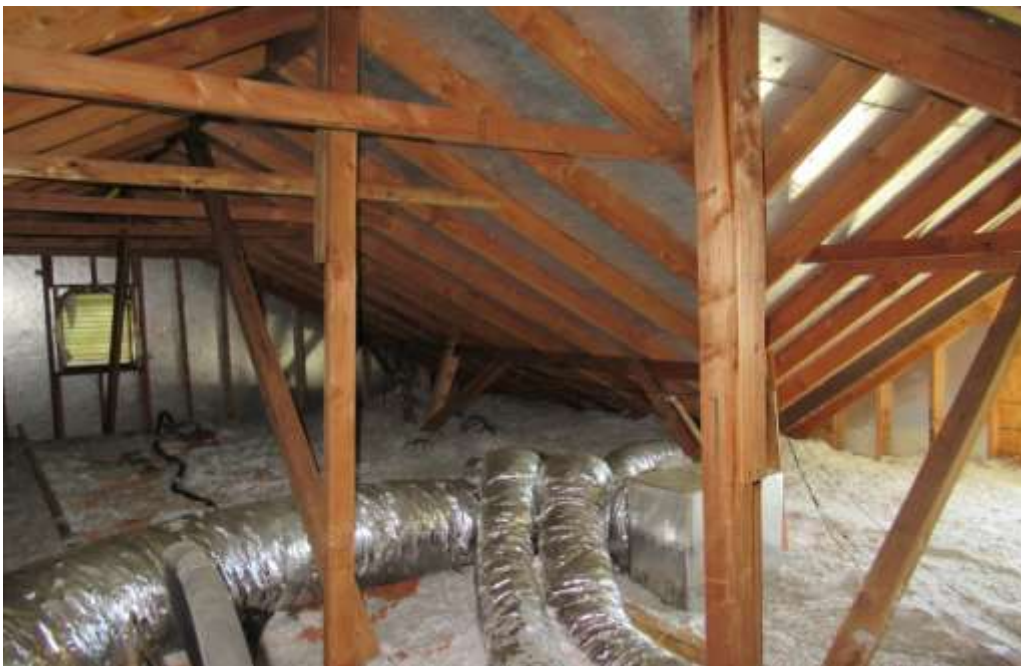
Attic 2. Except for a small area at the gable wall, the fire did not reach this space.

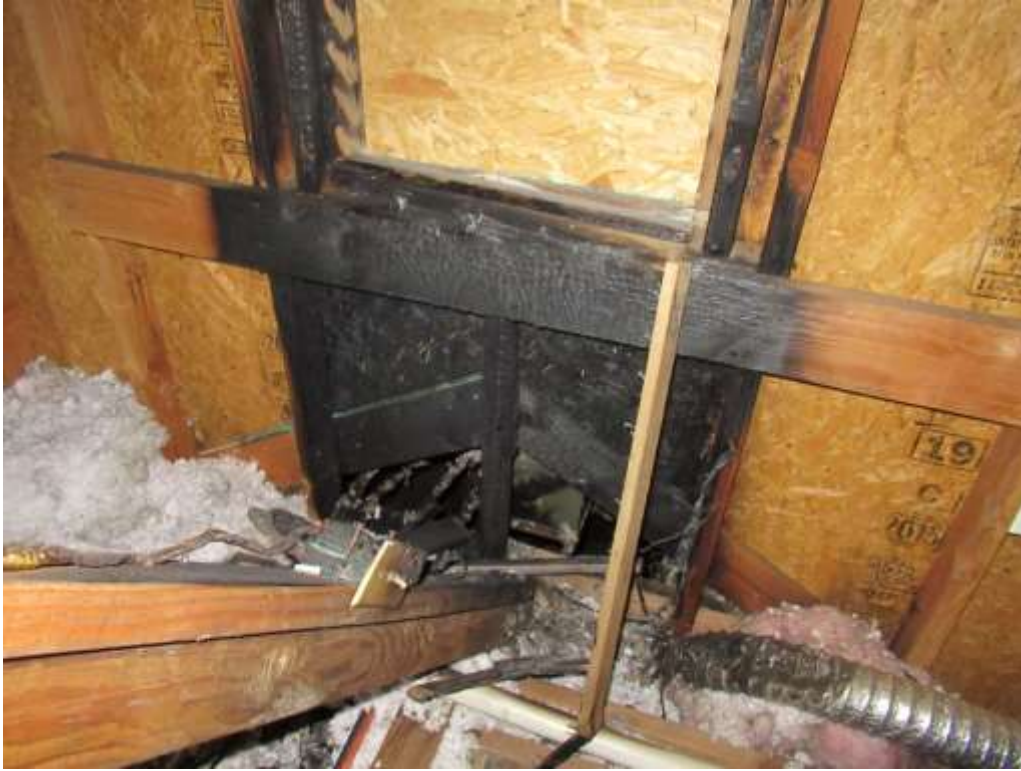
The exercise room is located just beyond and partially below the window at the upper part of this photo. The fire burned through the triangular opening at the bottom and up to and around the window. This was the limit to the fire damage in Attic 2.

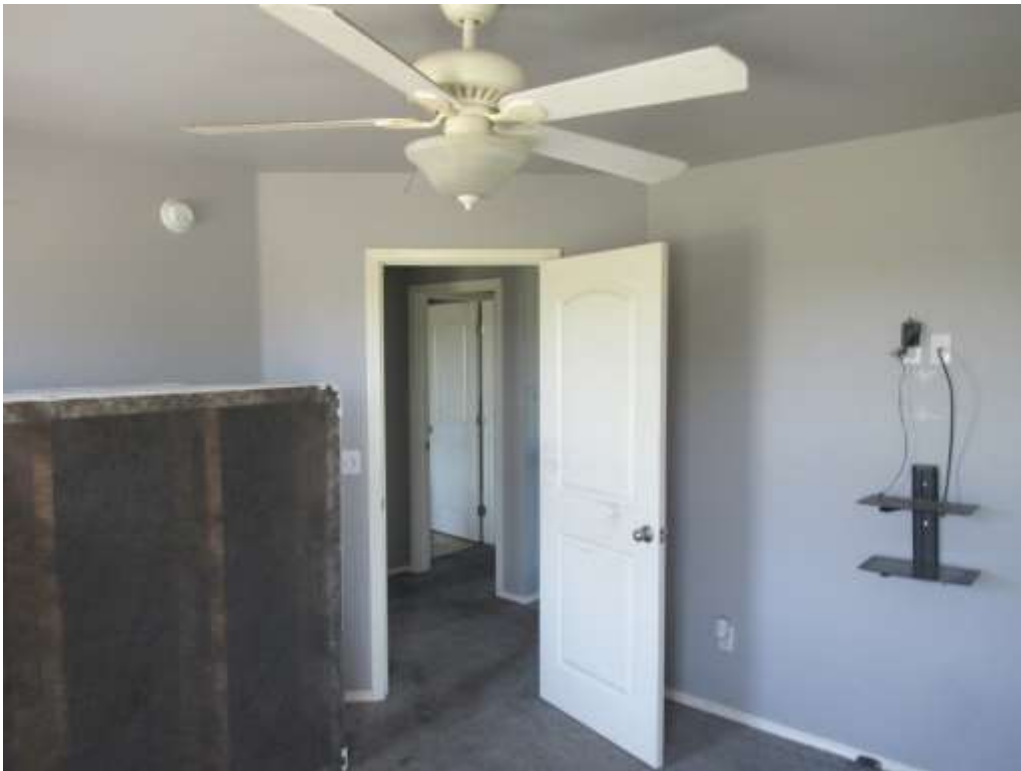
Upstairs Bedroom 1 had minimal soot settlement on the walls, doors, trim, lights, etc.

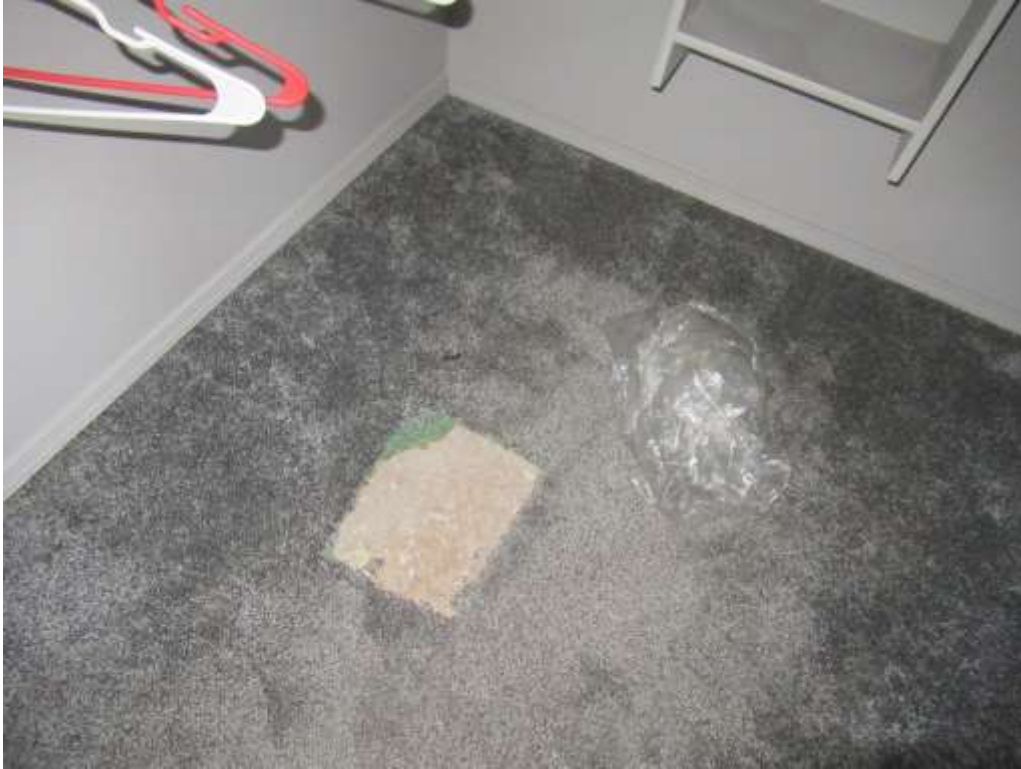
Bedroom 1 Closet with minimal soot present. A piece of the carpet and pad was removed to send to a third-party to determine the reasonable cost to replace the items.

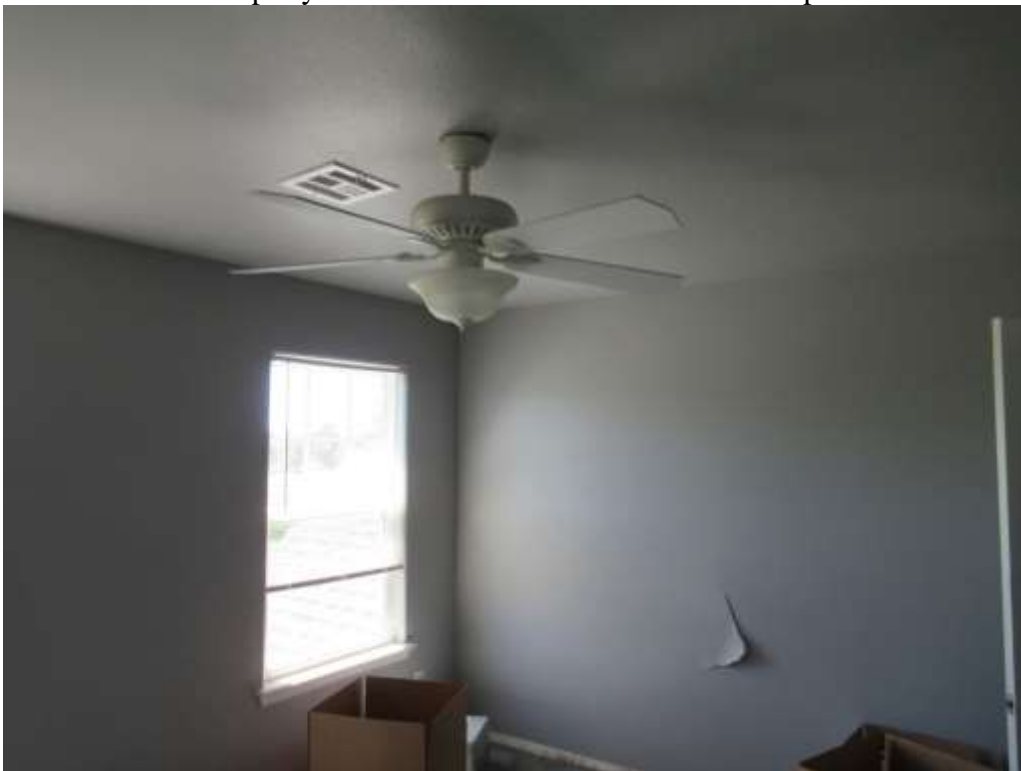
The west wall of Bedroom 2. The hole in the wall appears to have been caused by the fire department when engaging the fire in Bonus Room 1 nearly on the other side of the wall.

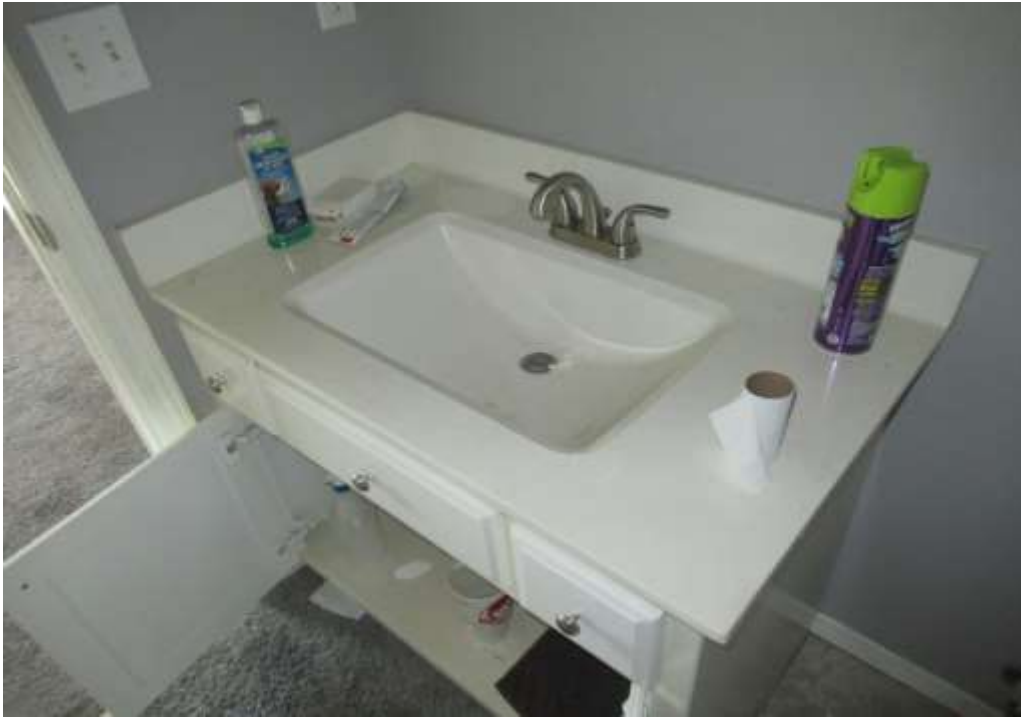
The vanity of Bathroom 2 with minimal soot accumulation on the countertop and fixture.
This condition was similar in the other upstairs bathroom.

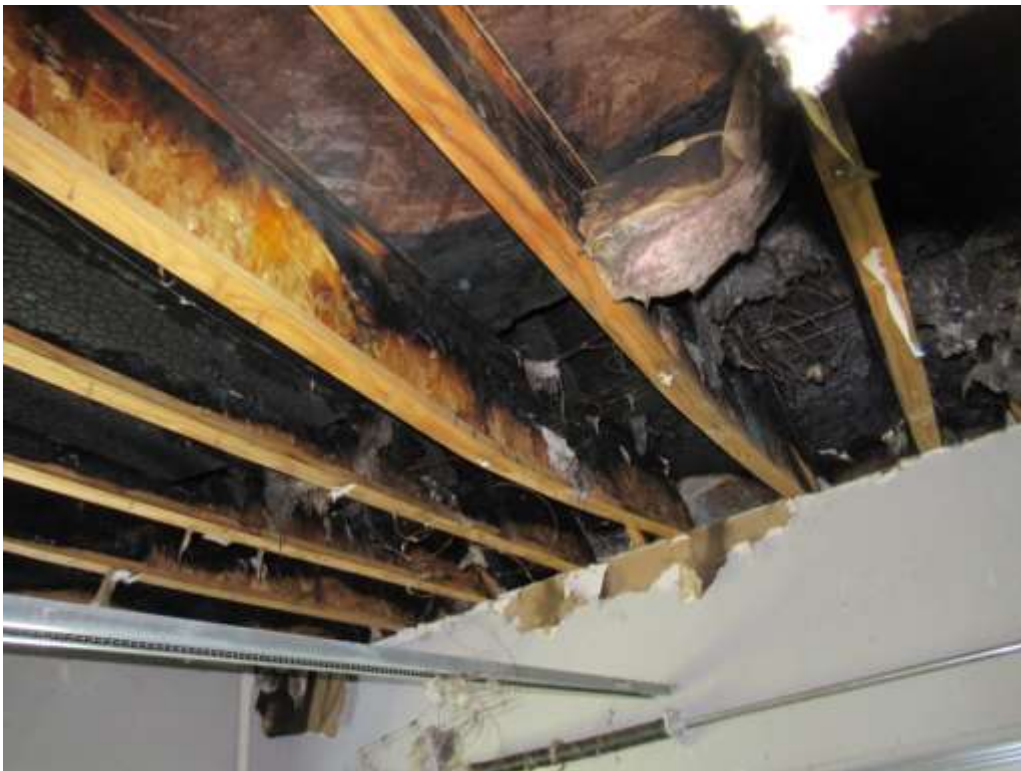
2. The ceiling of the two-car garage had been pulled down, likely by the fire department, which provided viewable access to the framing. It was found that the floor/ceiling I-beams above the garage and below Bonus Room 1 had begun to sag.

The joists which are sagging in the vicinity of the understood location of the fire's origin.

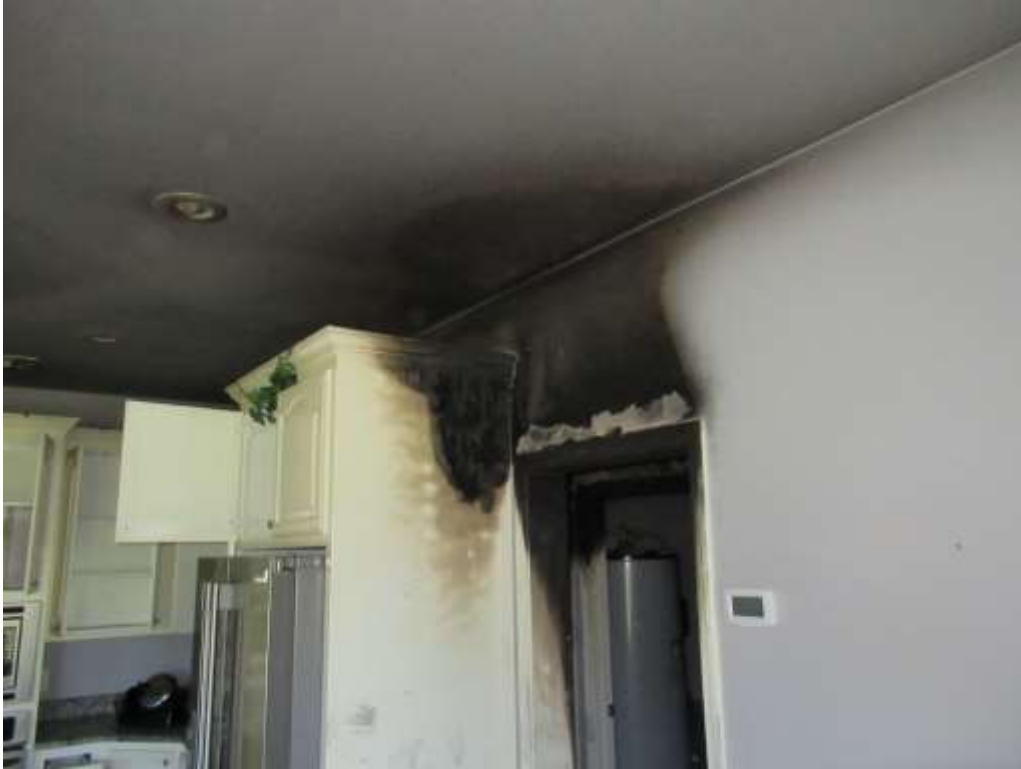
Fire damage to the wall and the top of the refrigerator bulkhead.

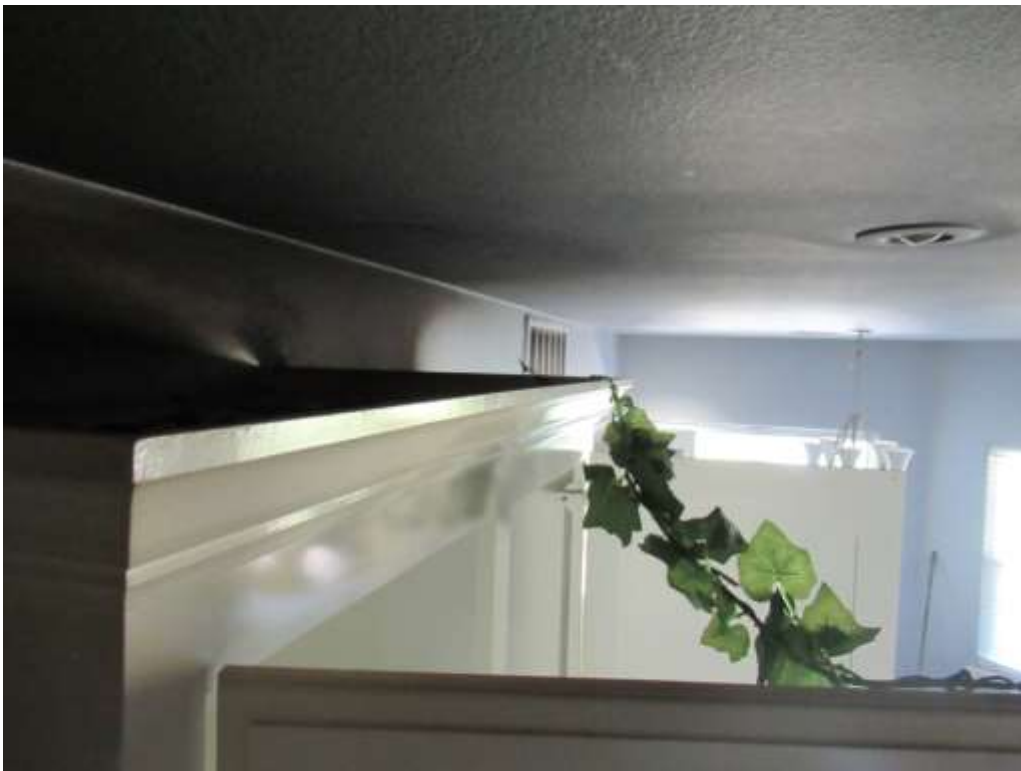
The top of the cabinet above the refrigerator with no damage. The other cabinets within the kitchen were in this same undamaged (by fire) condition.

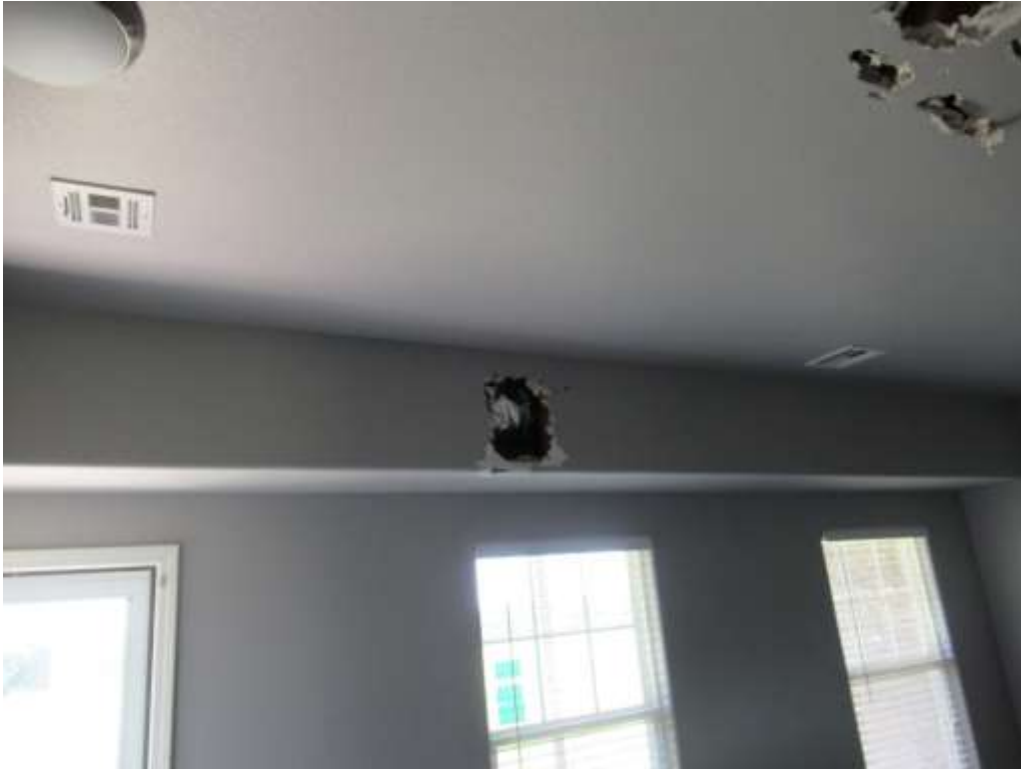
Holes in the ceiling and wall of the Dining Room.

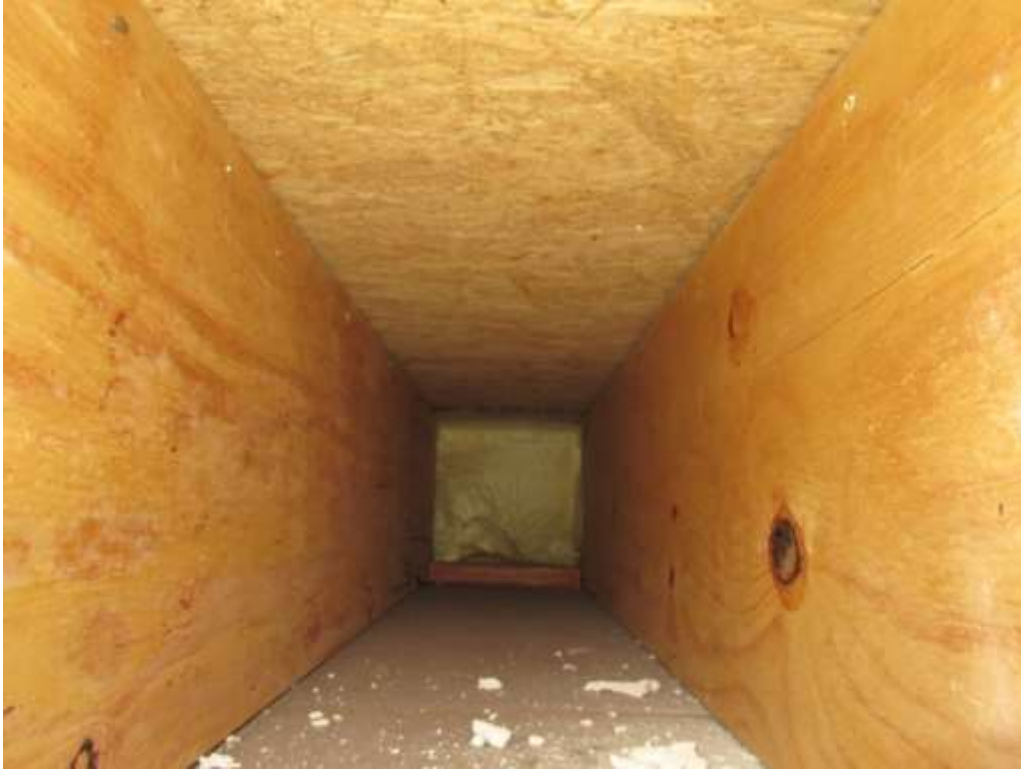
The inside of one of the cavities showing it to be clean of smoke damage.

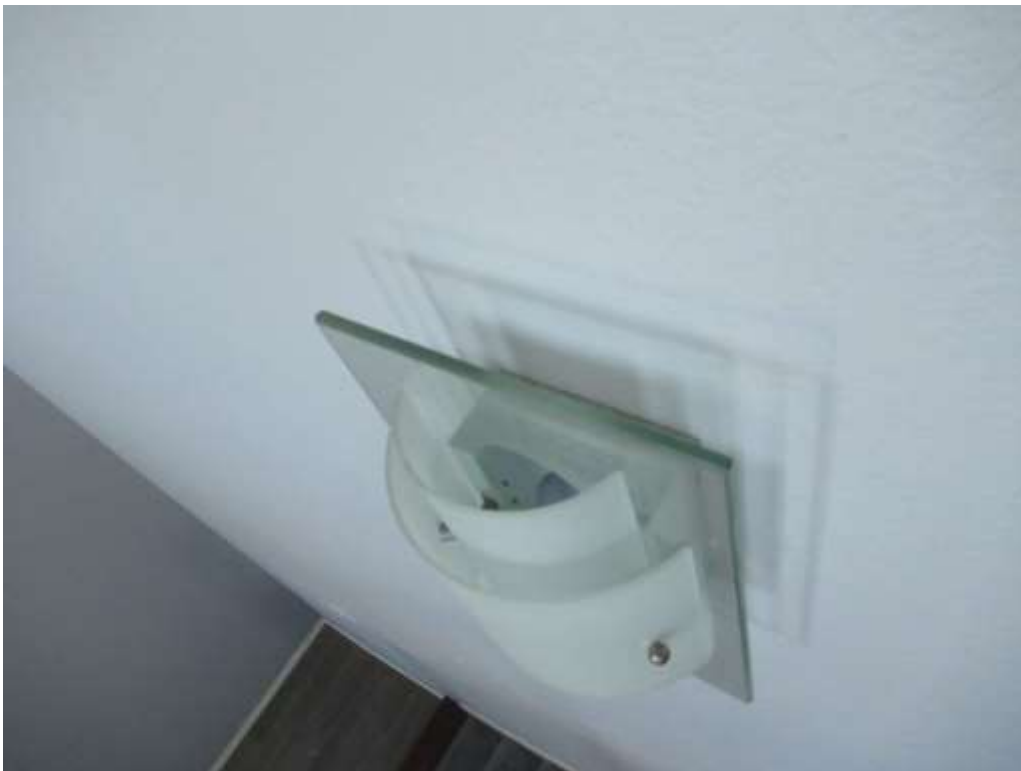
A sconce light installed at the stairwell to the second-floor bedrooms. Cleaning of this light fixture will address the minimal soot accumulation.

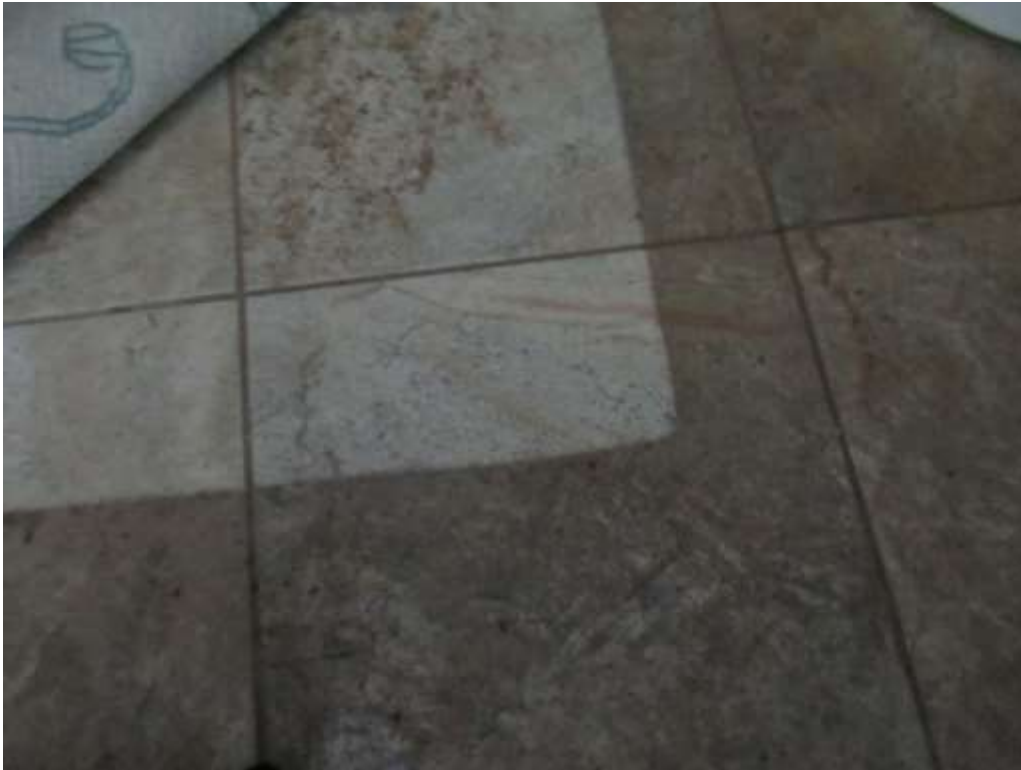
Location of the Guest Bath test clean before cleaning. A floor mat had protected the tile from smoke and soot.

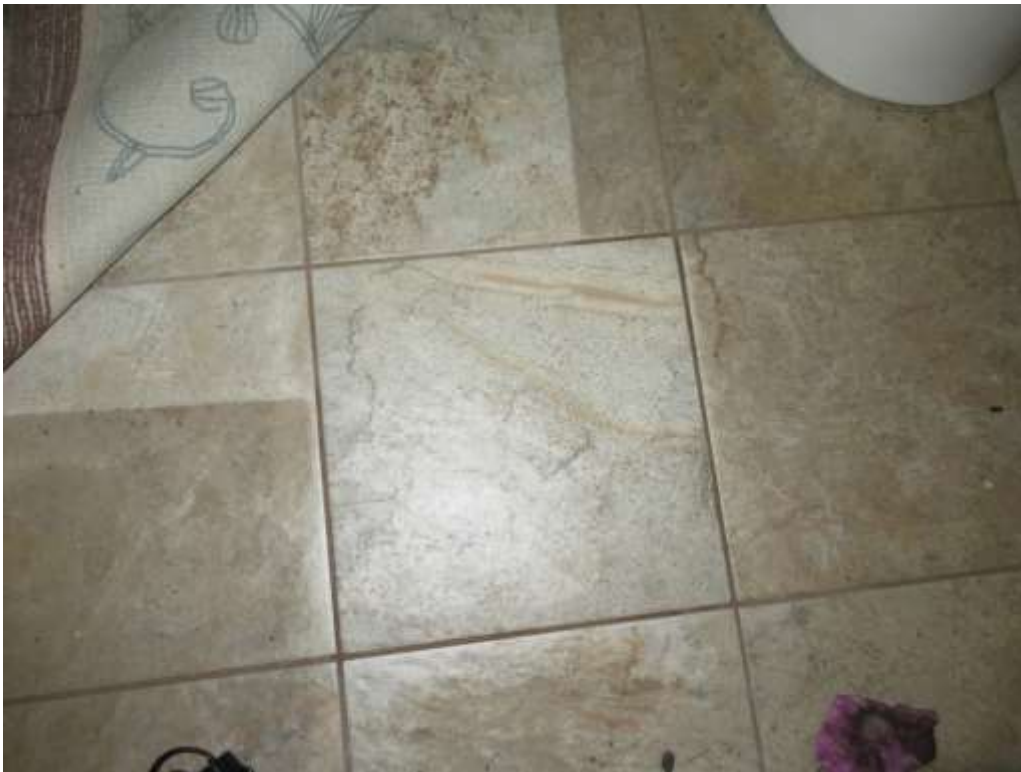
The same area after the test clean. The soot has been fully removed from the tested area.

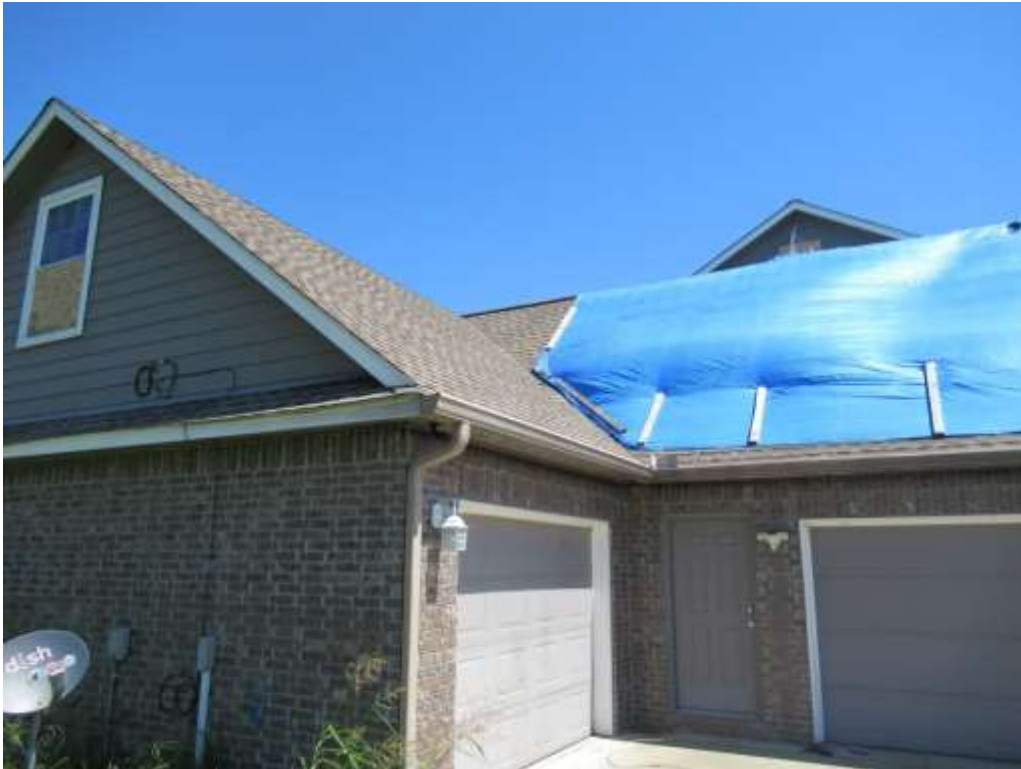
The tarp installed over the double garage with the partially boarded window of the Theater Room.

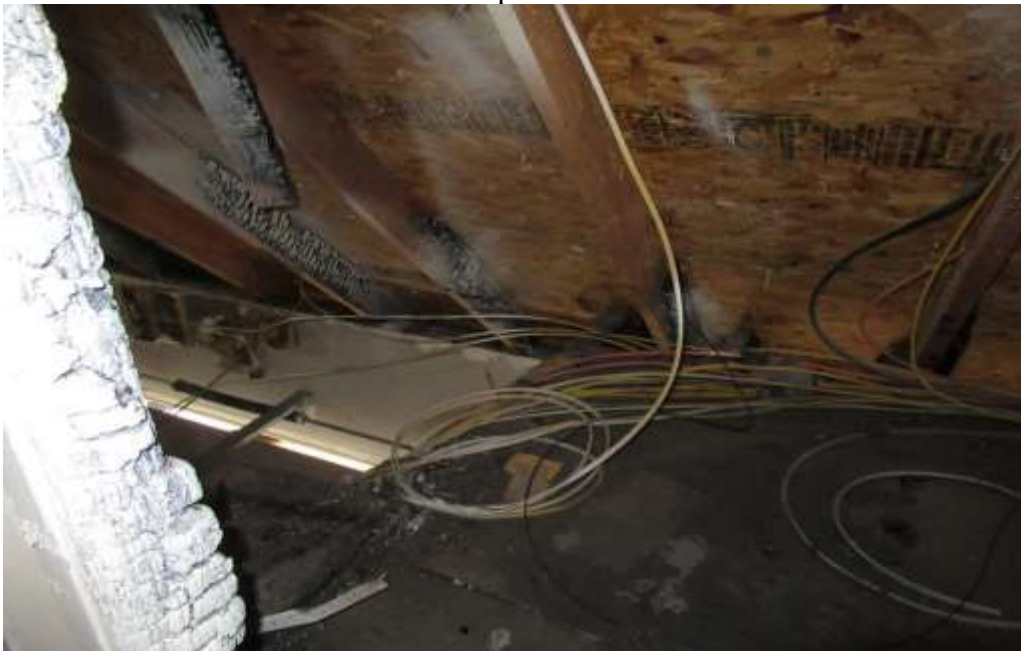
The roofs decking has been replaced but partially charred rafters remain.

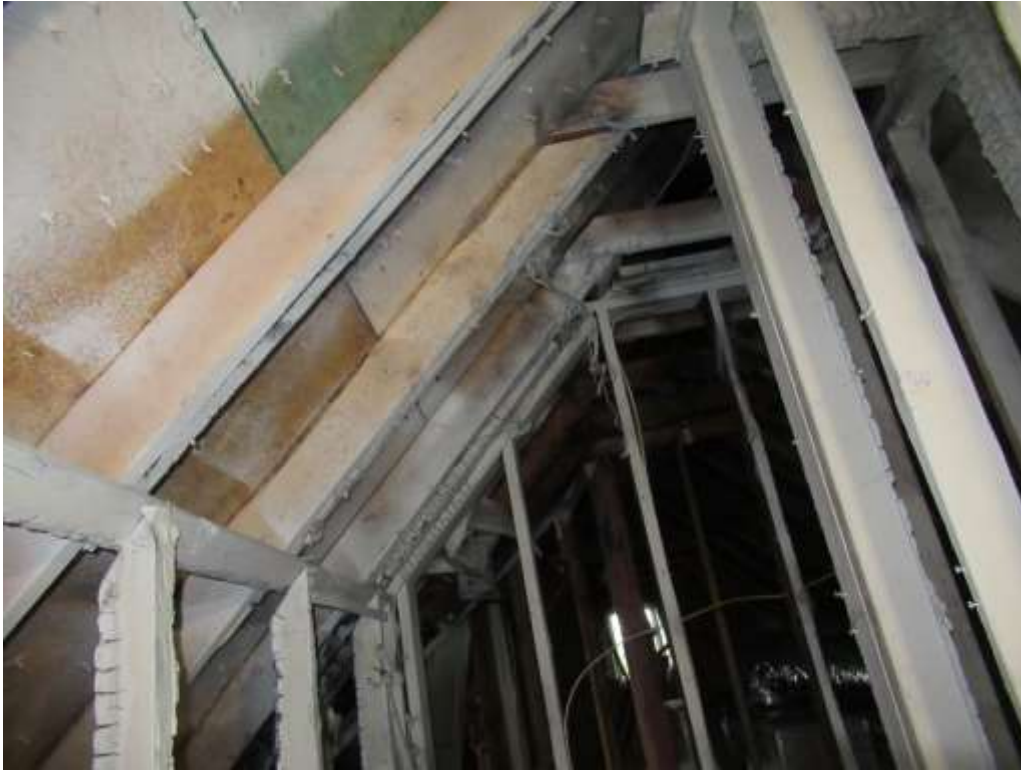
This area, above the origin of the fire, shows new decking and new rafters attached against the fire damaged rafters. An odor sealer has been applied to the old framing members.

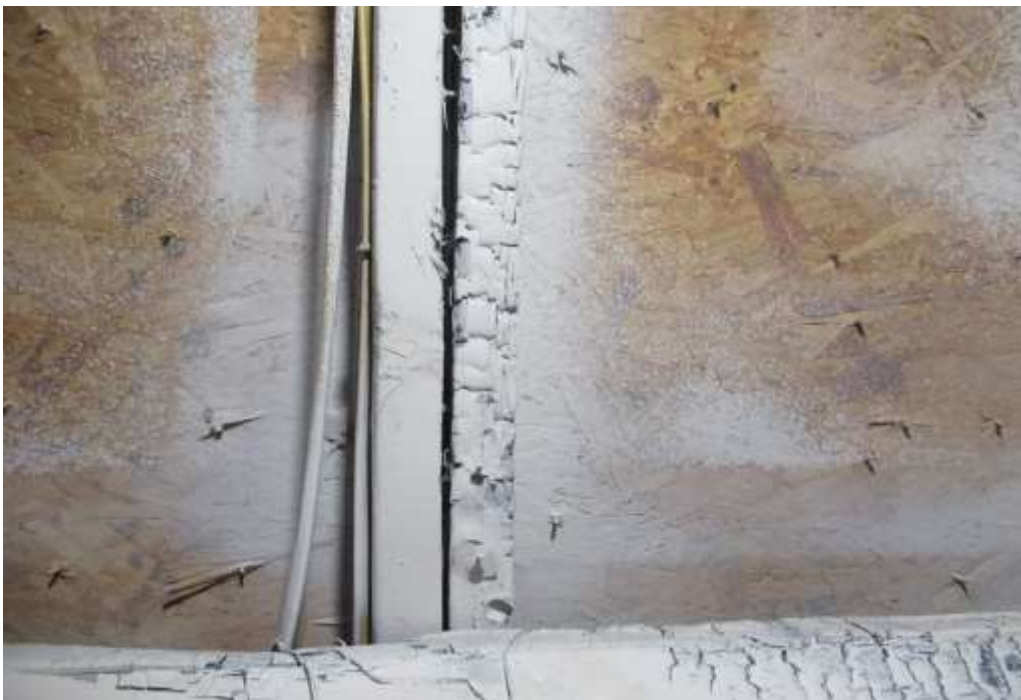
A fire damaged rafter with a new sister rafter. Both have been sealed.

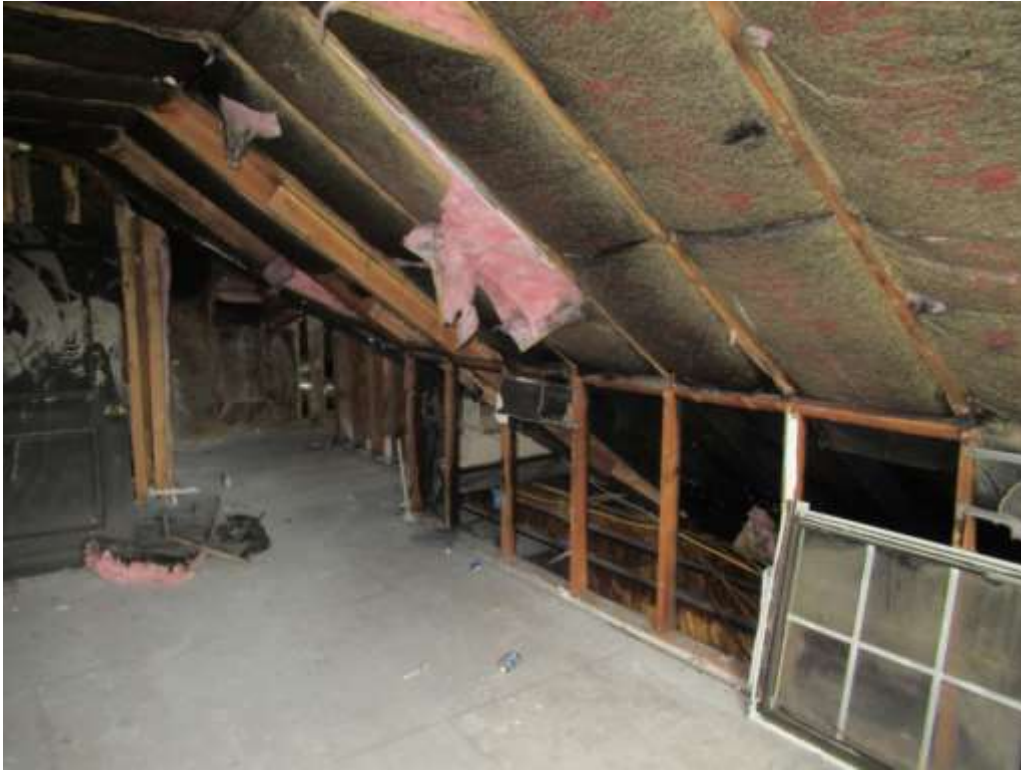
The south wall of the Theater Room. The finishes have been removed but the framing was not replaced despite a new roof being installed above this section of the house.

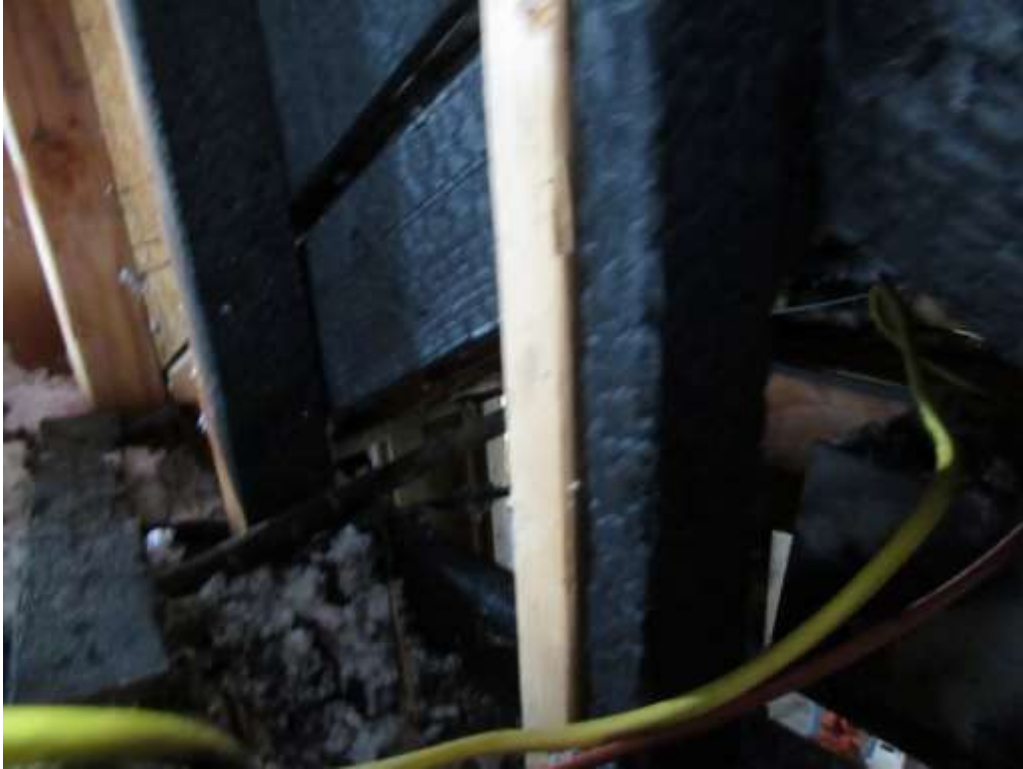
Some new framing below the Attic 2 window. Other fire damaged framing was left in place.

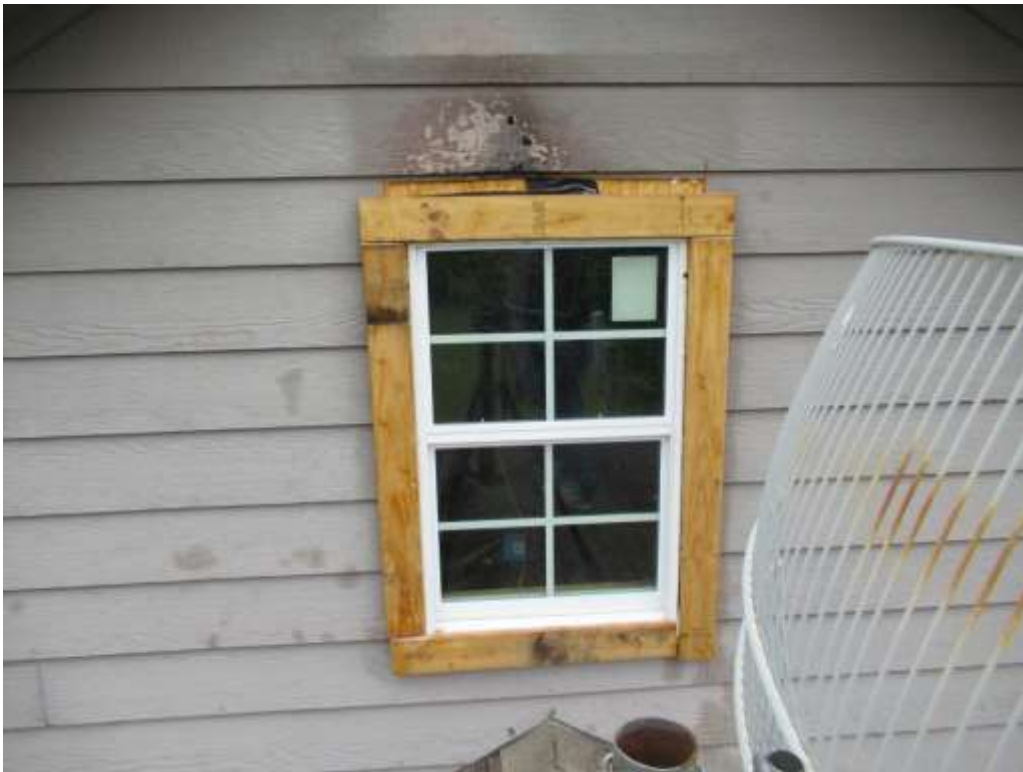
The exterior side of the new window in the Attic 2 gable. The siding was not replaced.

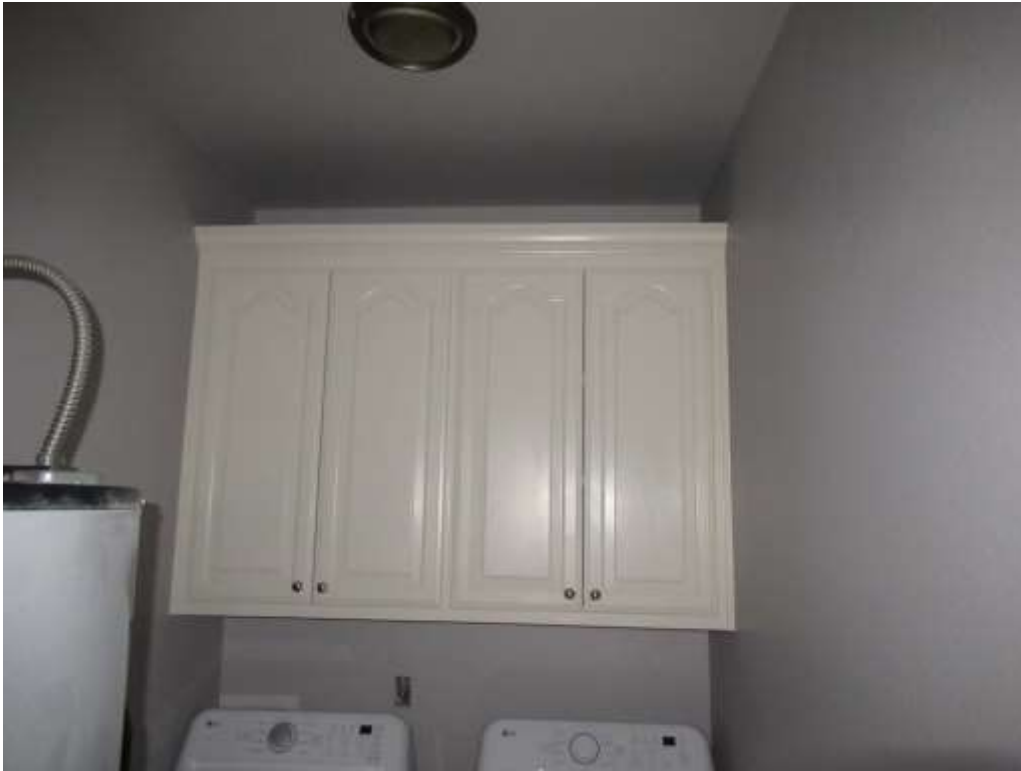
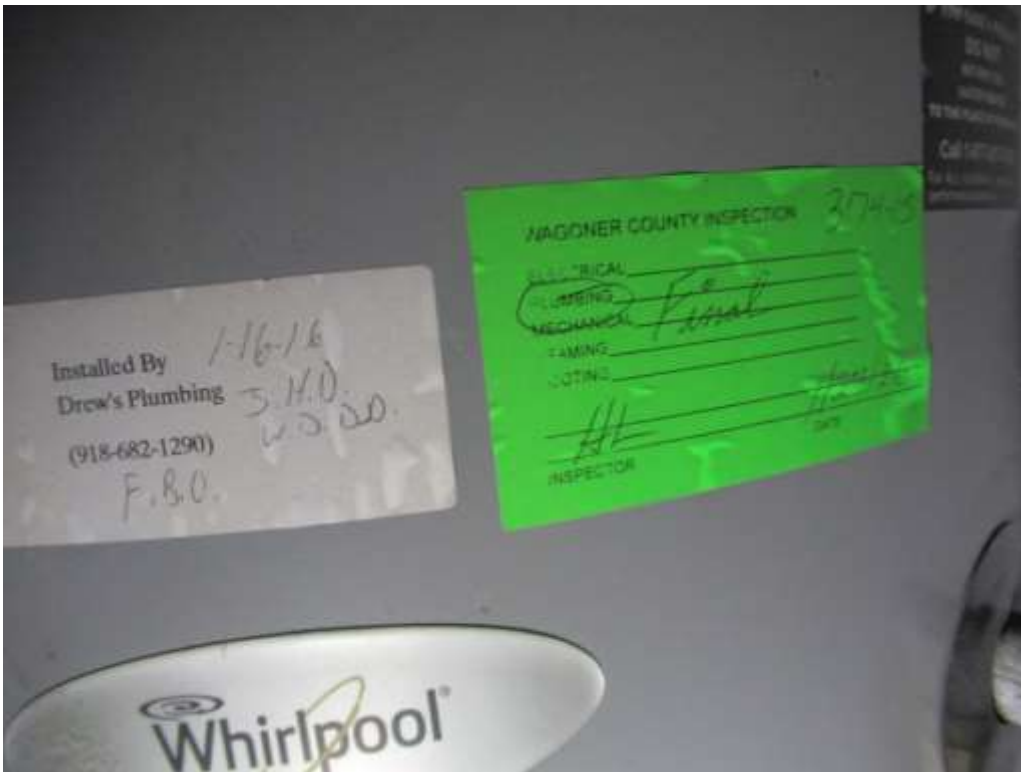
The original hot water heater located in the laundry room. The installation and inspection stickers are dated January 2016.

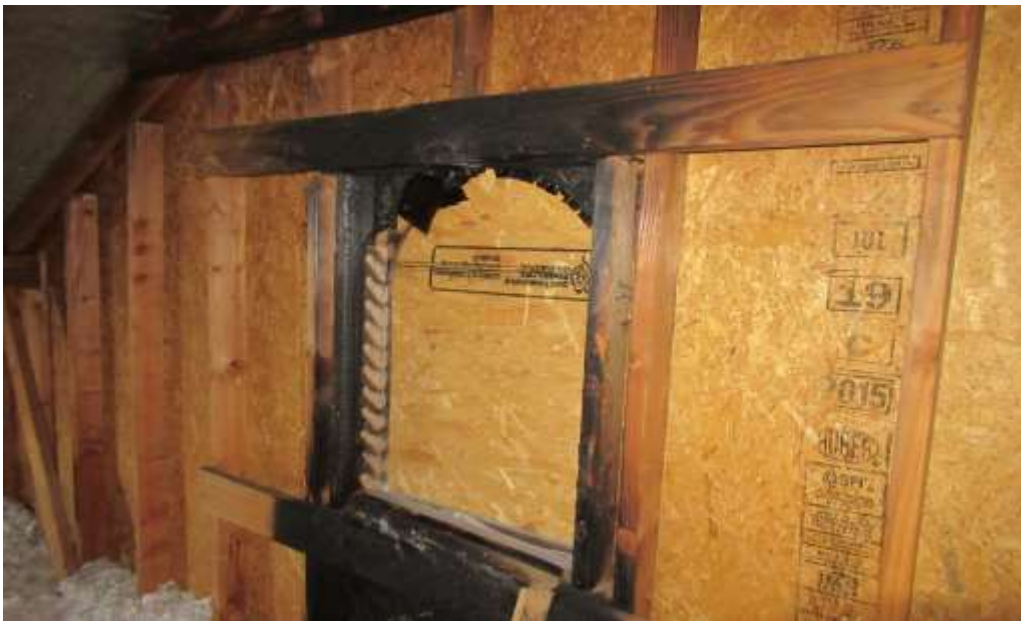
2. Williams noted the fire damage around the Attic 2 gable window. However, he recommended that the entire wall be re-framed. As the damage was limited to the immediate window area, it would not be necessary to re-frame the entire wall. It is a common practice to repair fire damage within a framed section without replacing the entire section.

The fire damage is limited to the window framing and the portions of the studwall just below the window. It would not be necessary to replace the entire wall, measuring approximately 32' wide, to repair this damage.

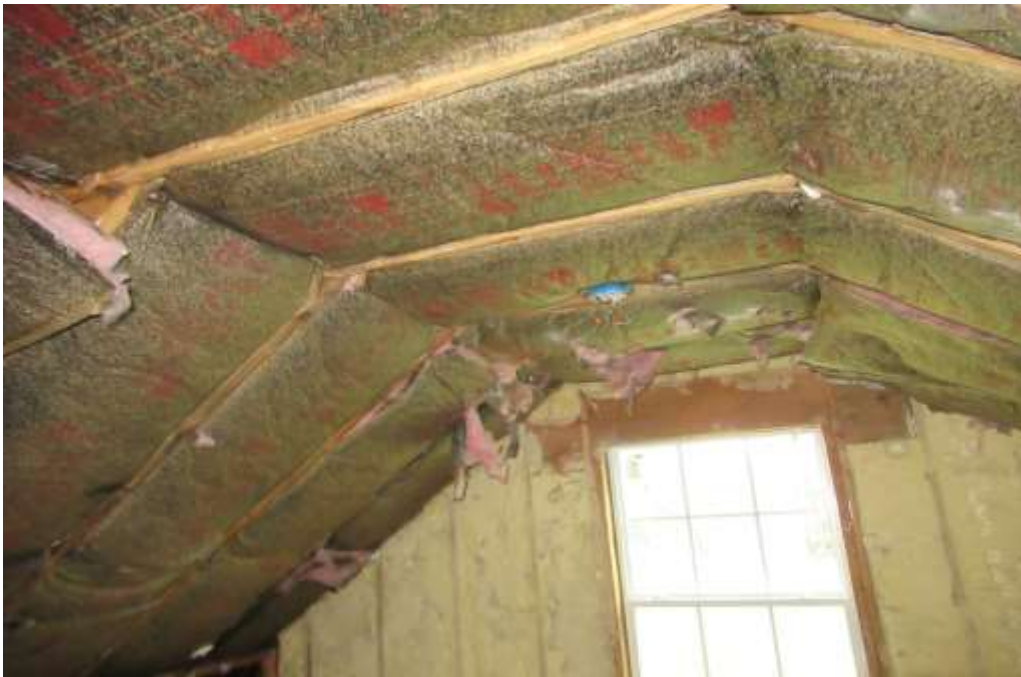
4. Williams seems to recommend that all roof and second floor framing around the Bonus Rooms be replaced due to fire damage. At the time of his and my 2021 inspections, it was evident that this recommendation was too broad and unnecessary. The photo on page 12 of this report documents the lack of damage is the north section of the second-floor framing and roof. Williams seems to recommend replacing this area of framing. My 2023 inspection, which occurred after the finishes had been removed from the Theater Room, shows the fire did not burn over this room.

The south sloped ceiling of the Theater Room is on the left. The fire spread from the area of the attic farther to the left of this photo. This photo shows the fire was blocked at the short wall of the Theater Room and contained within the attic space. It would not be necessary to replace all this framing and additional framing to the right of the photo as Williams seems to recommend.
